TECHNICAL NOTE D-1458

PRELIMINARY INVESTIGATION OF EFFECT OF HYDROGEN ON

STRESS-RUPTURE AND FATIGUE PROPERTIES OF AN

IRON-, A NICKEL-, AND A COBALT-BASE ALLOY

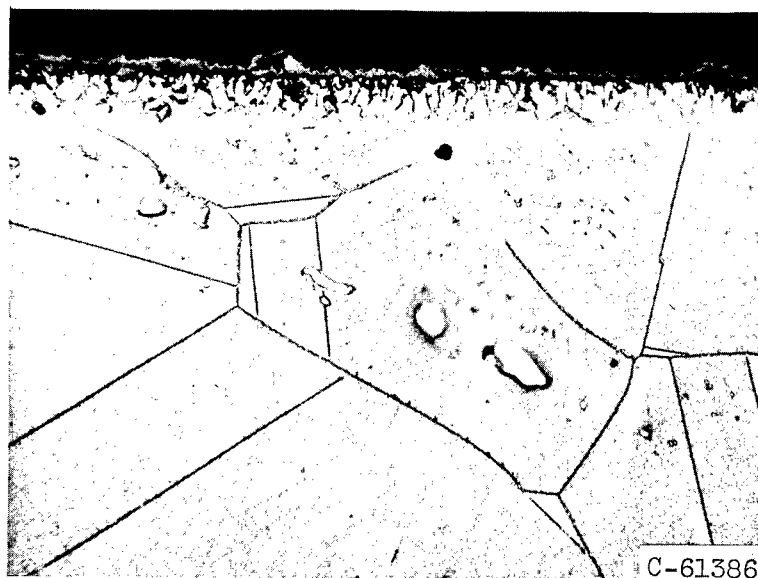
(b) Inconel 700; fatigue test; life,  $47.4 \times 10^6$  cycles (401.6 hr).

Figure 10. - Continued. Typical specimens showing both internal and external surfaces in area some distance from region of failure. Internal surface exposed to dried air; external surface exposed to relatively humid air. X500.

Figure 9 shows typical microstructures along both the internal and the external surfaces of specimens of each alloy after air tests in the areas near the specific points of failure. Figure 10 presents similar

photomicrographs of additional specimens of each alloy, which show regions away from the failure area. It is apparent from these figures that, in general, a considerably thicker scale was formed on the external surface exposed to relatively humid air rather than on the internal specimen surface exposed to dried air. This scale extended through both the cracked and uncracked areas. Microscopic examination indicated that considerable oxidation occurred in the cracks that formed near the point of failure of air-tested specimens in all the materials investigated. Oxidation occurred in the cracks that extended from the internal surface as well as those that extended from the external surface. This was most apparent in stress-rupture tested specimens and is best illustrated in figure 9(c). No oxidation occurred in the cracks that extended from the internal surfaces of specimens exposed to hydrogen.]
